**NWOS BRIDGE INSTALL
BID NO. 2023-031**

ADDENDUM NO. 1
DATED: January 3, 2024

GEOTECHNICAL STUDY

Niver Canal Bridge
Northglenn, Colorado

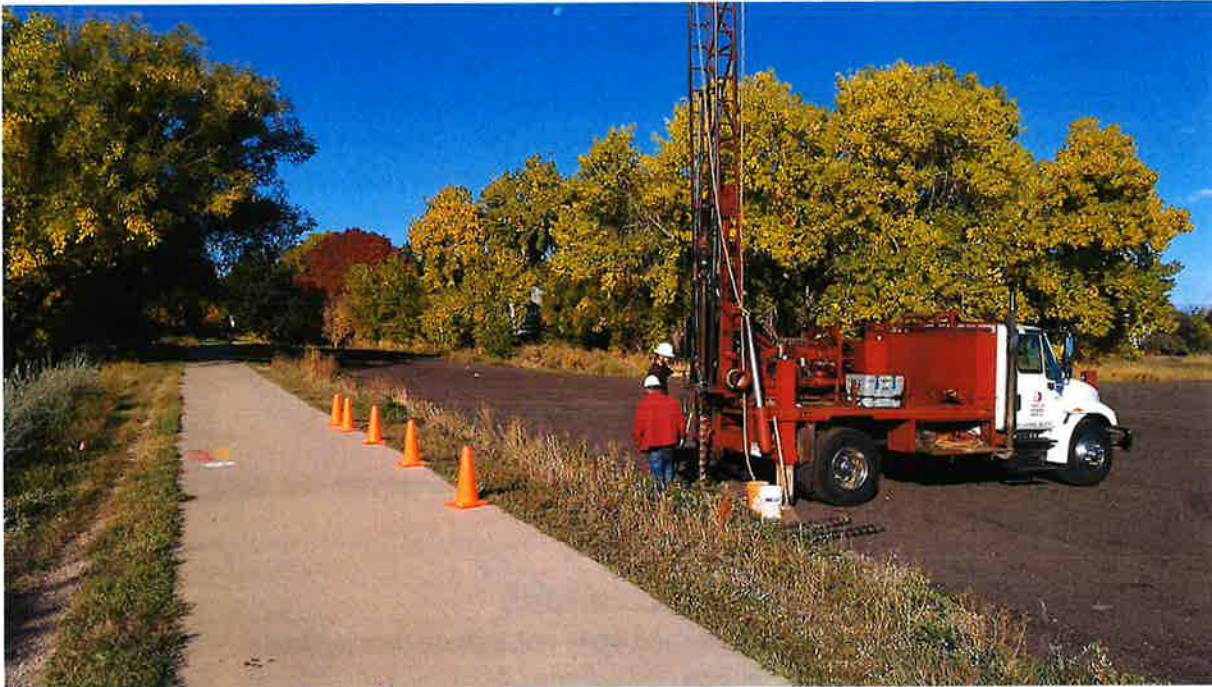
Photo 1. View looking at drilling Boring B-1.

Subsurface conditions were explored on October 13, 2022 by drilling two borings at the locations indicated in Figure 2. Borings were drilled about 39-1/2 and 24-1/2 feet deep. Graphical logs of the subsurface conditions encountered and further explanation of the exploration are presented in the boring logs contained in Appendix A.

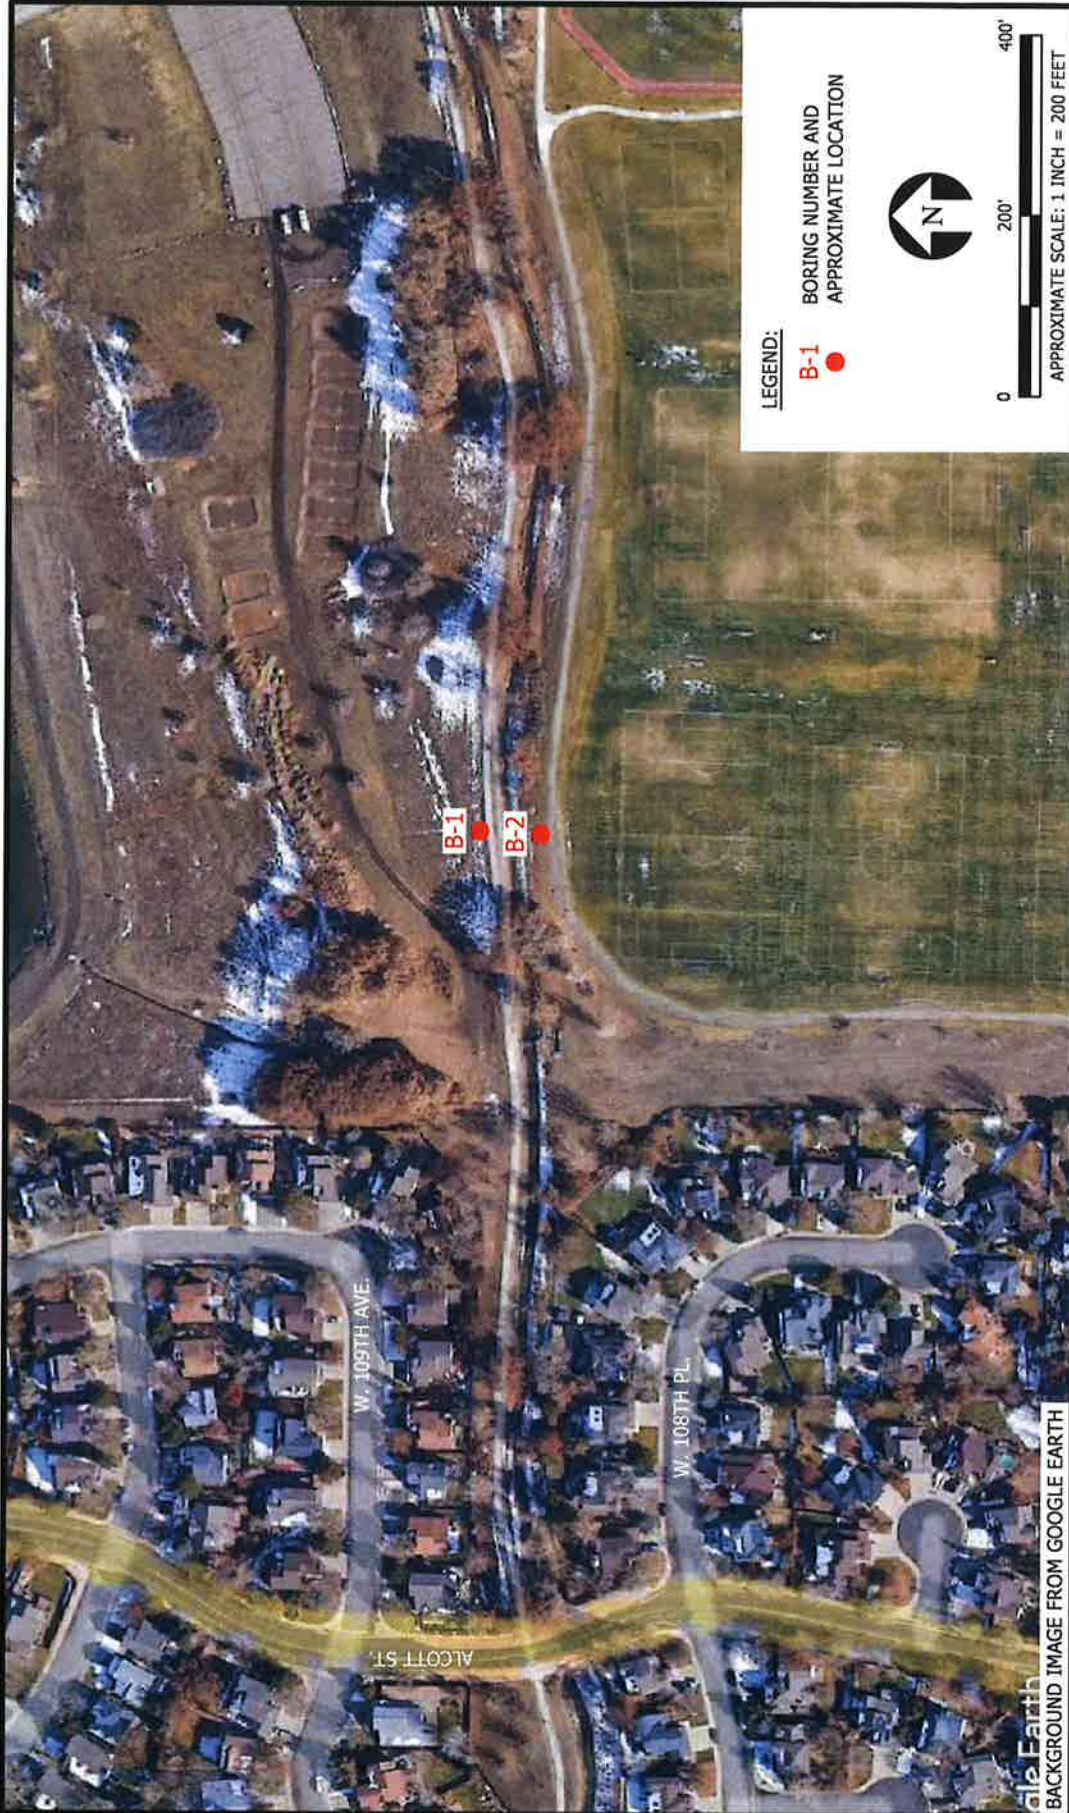
PROJECT NO: 22.137		<p>FIGURE 2</p> <p>Site Plan and Boring Locations</p>	
PROJECT NAME: Niver Canal Bridge			
DRAWN BY: JBE	CHECKED BY: JAC2		
DWG DATE: 10.14.22	REV. DATE: --

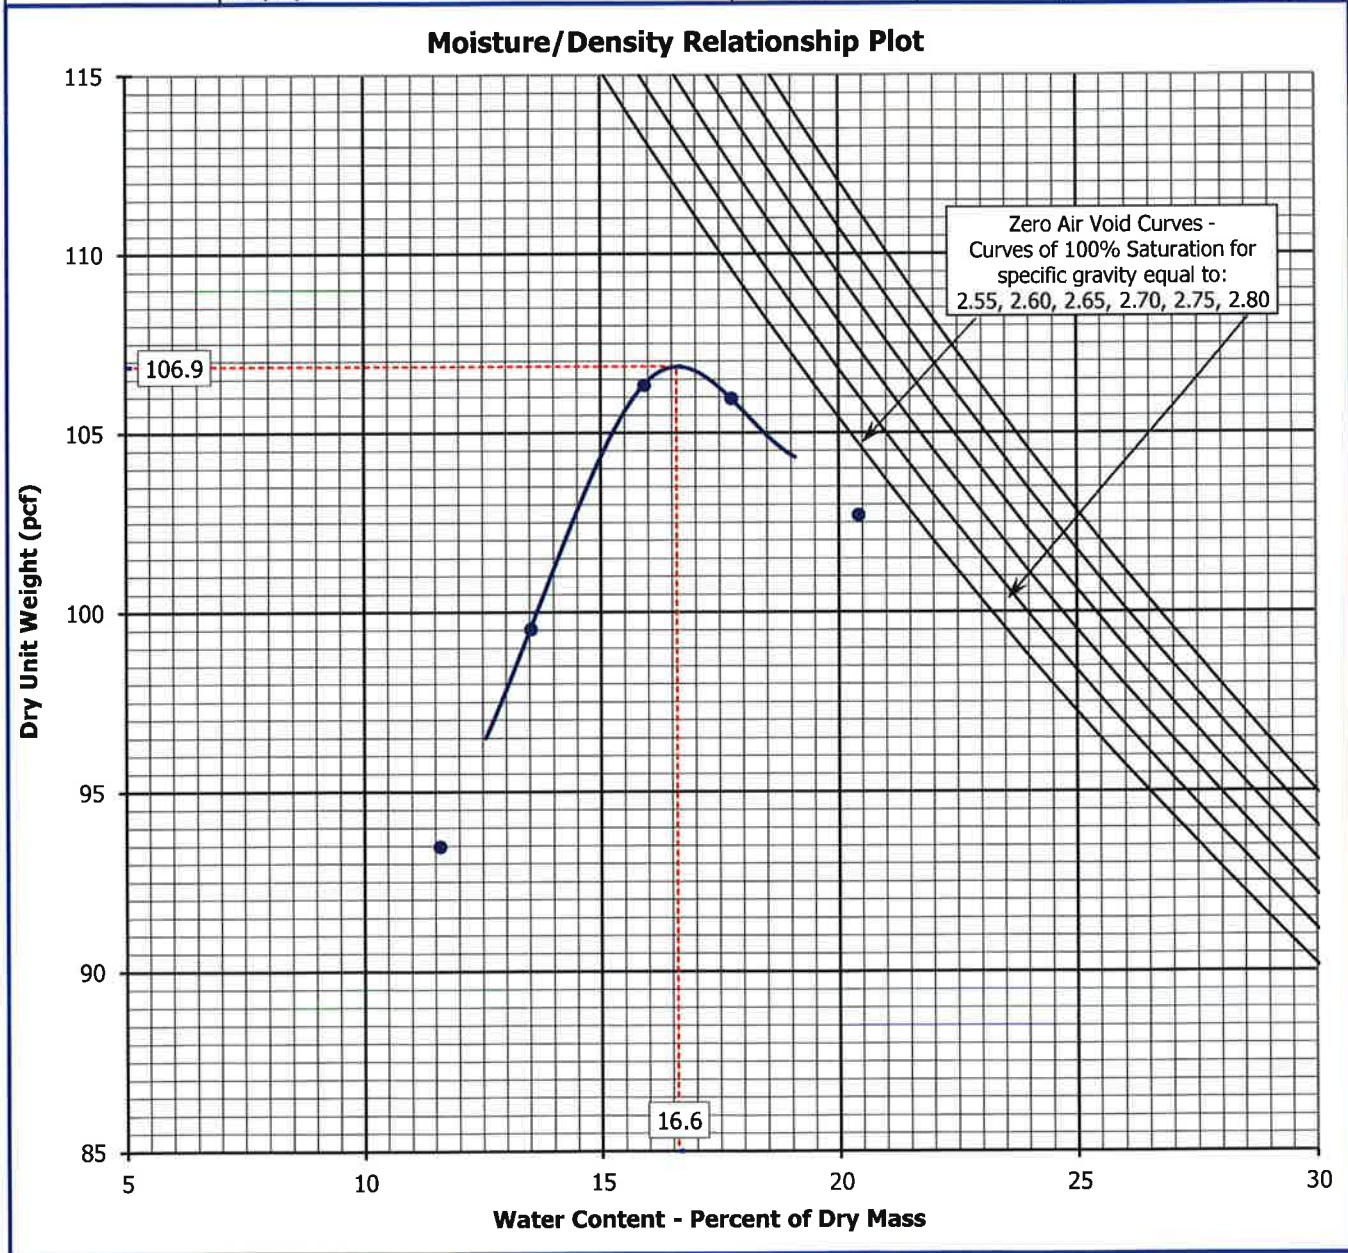
Project number	22.137	Date	October 28, 2022
Project name	Niver Canal Bridge	Technician	C. Kilcullen
Lab ID number	F222223	Reviewer	G. Hoyos
Sample location	B-2 at 0 to 10 feet		
Visual description	MIXTURE FILL AND NATIVE: CLAY, sandy, brown

Test Procedures and Methods		Optimum Proctor Values and Correction Factors			
ASTM/AASHTO compaction test procedure designation	ASTM D698 (Standard)	Laboratory maximum dry unit weight (pcf)	106.9		
Method		Laboratory optimum moisture content (%)	16.6		
Classification		Minus No. 200 (%)	LL	PL	PI
USCS	(CL) Sandy lean clay				
AASHTO	A-6(13)	66.8	37	14	23

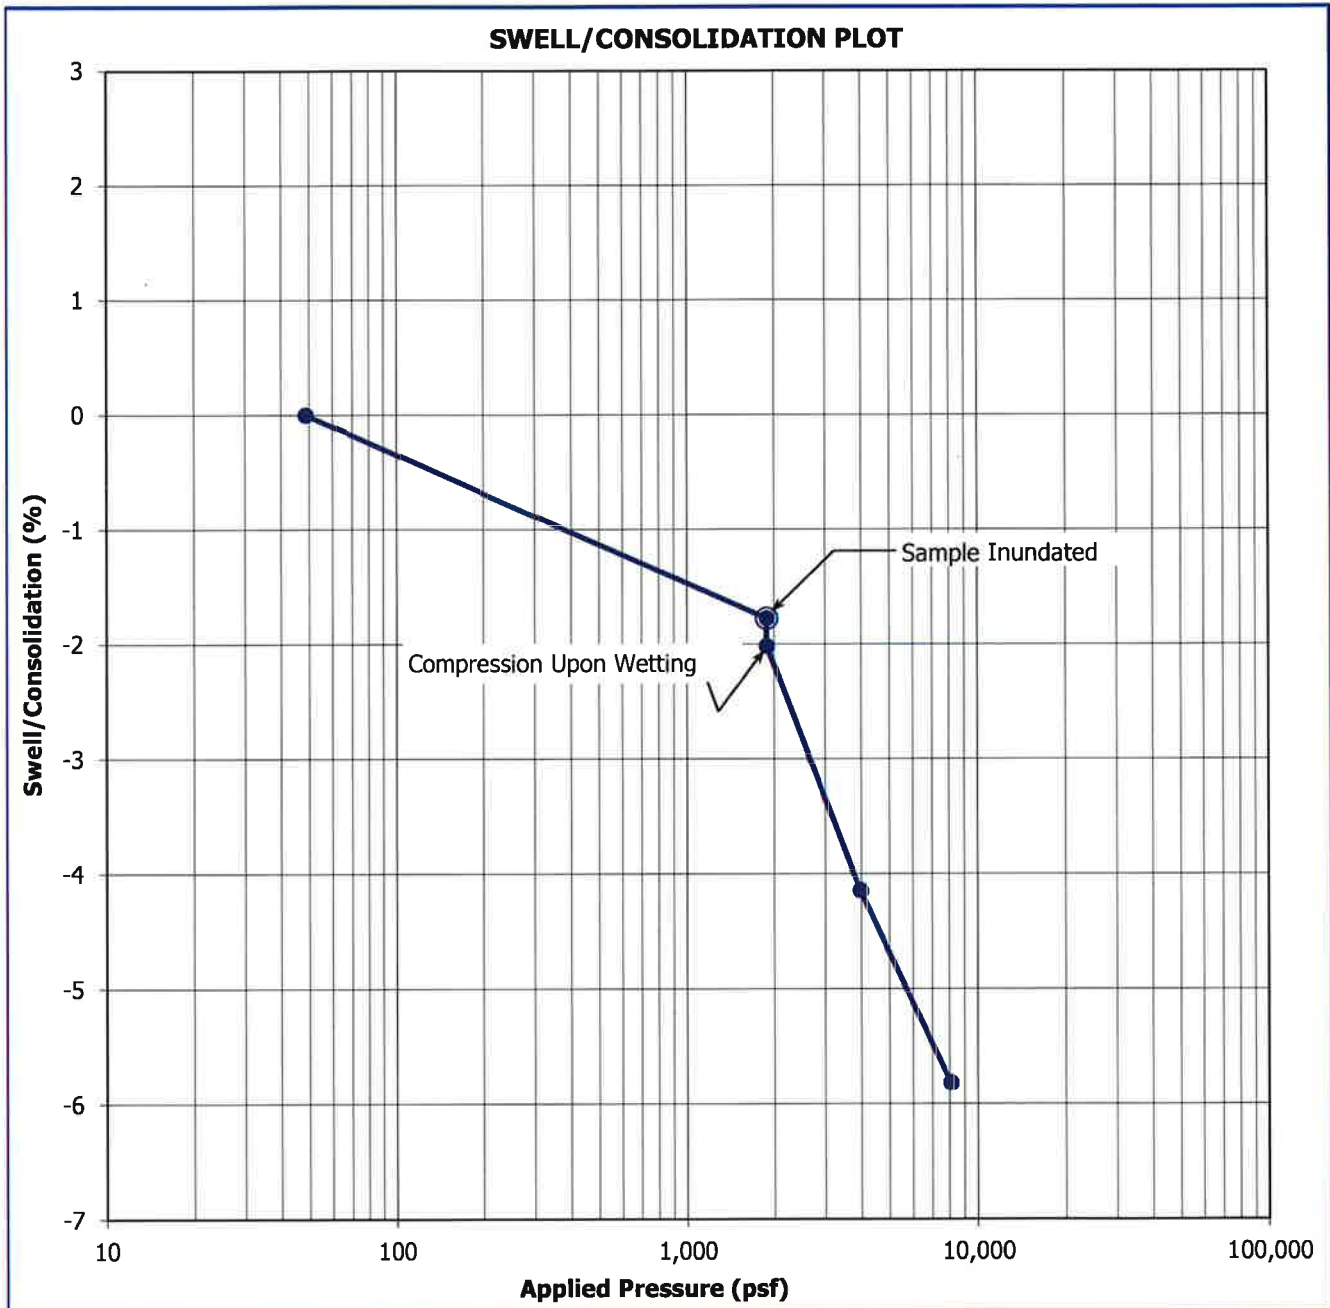
Sample Location	Sample Depth (ft)	Visual Description of Sample	Dry Density (pcf)	Moisture Content (%)	Inundation Pressure (psf)	Volume Change (%)	Swell Pressure (psf)
B-1	9	SANDSTONE: SAND, with interbedded clay, brown	106.8	6.0	1,882	-0.2	N/A

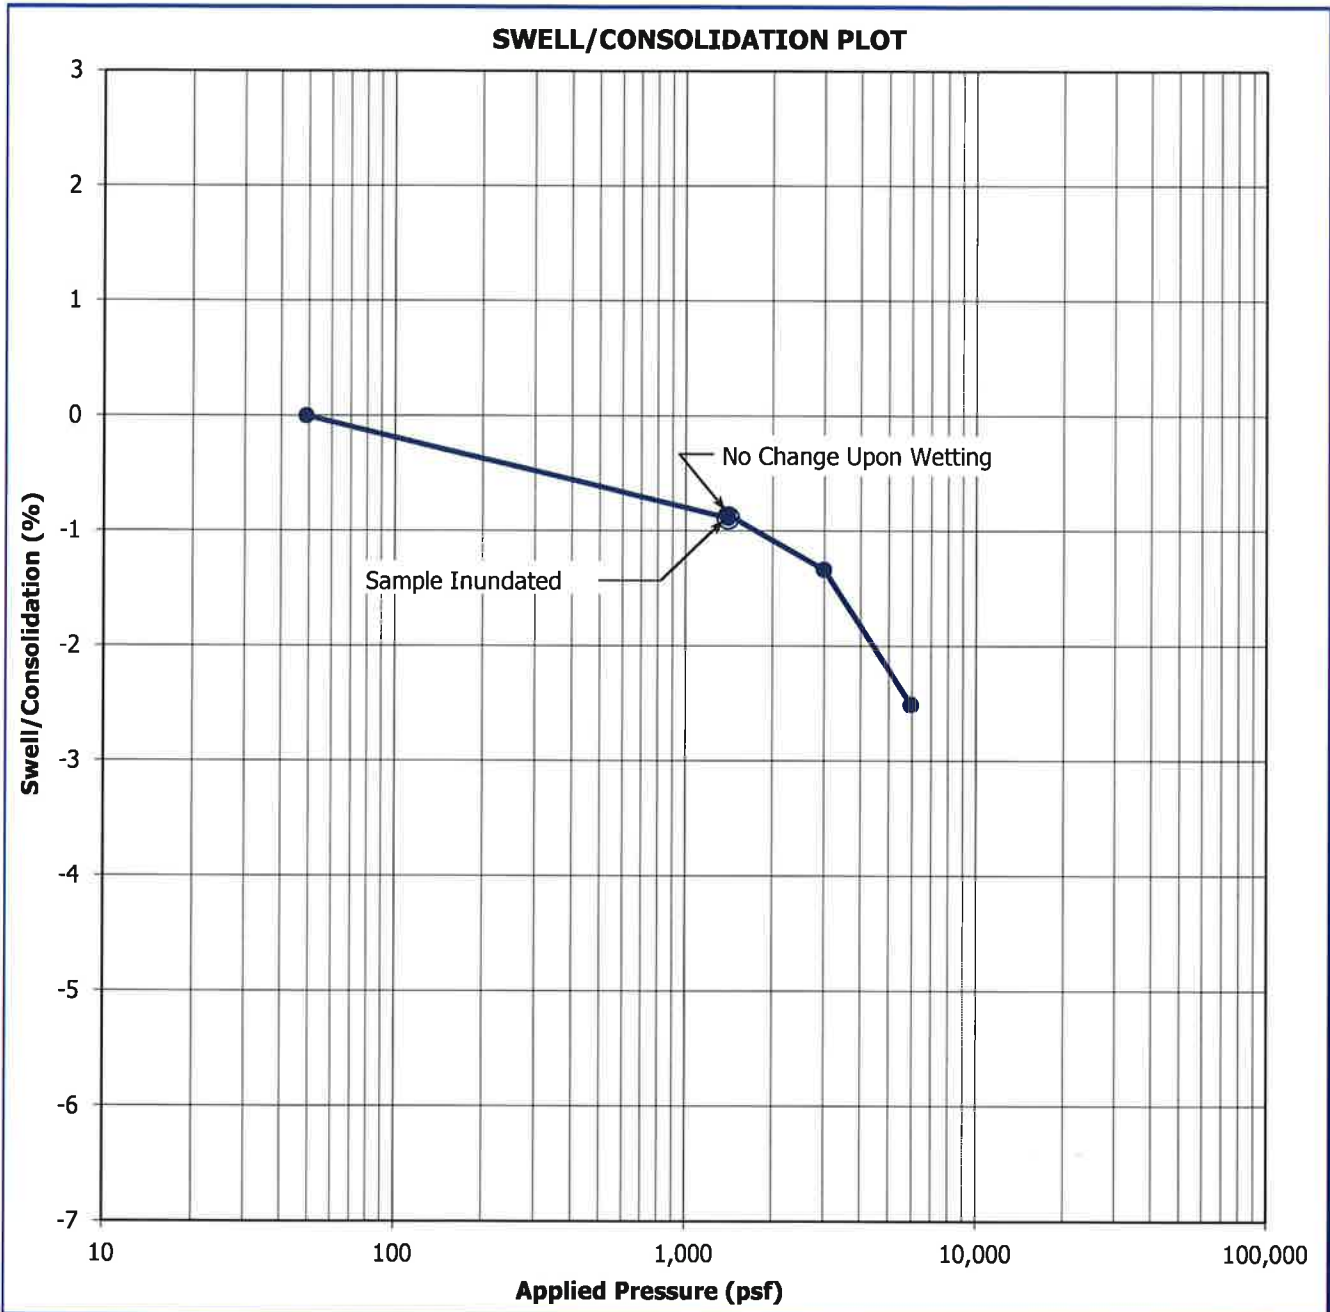
Sample Location	Sample Depth (ft)	Visual Description of Sample	Dry Density (pcf)	Moisture Content (%)	Inundation Pressure (psf)	Volume Change (%)	Swell Pressure (psf)
B-1	14	CLAYSTONE, with sand, gray	103.7	21.3	1,400	0.0	NA

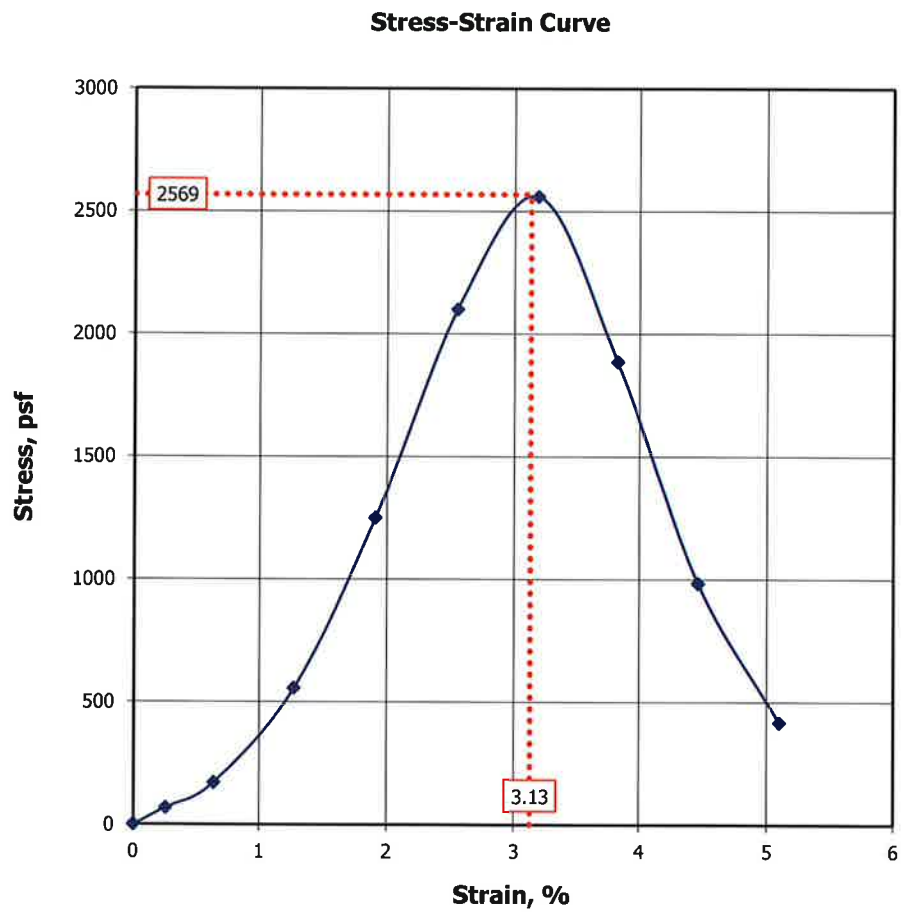
Unconfined Compressive Strength (q_u):	2,569 psf	Density (pcf):	108.6
Shear Strength (S_u):	1,285 psf	Moisture:	18.1

Axial Strain (%)	Axial Stress (psf)
0.0	0.0
0.3	68.4
0.6	170.3
1.3	556.0
1.9	1248.8
2.5	2099.7
3.2	2560.0
3.8	1883.8
4.5	982.5
5.1	418.2
